Photographs of Minefield Areas in Egypt

Western Desert Problems

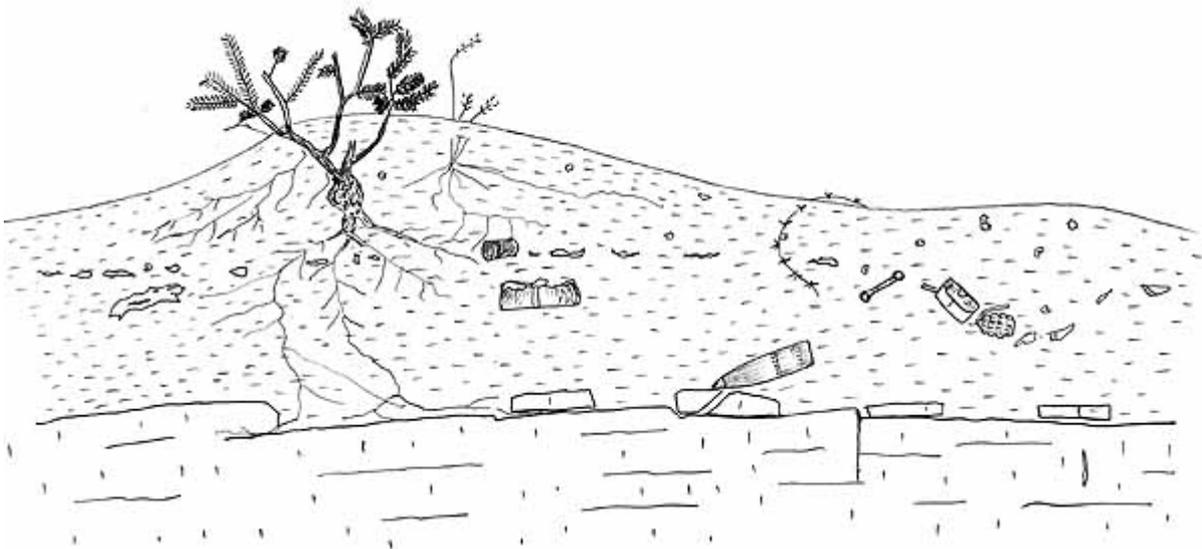
Drawing: Typical ground structure in Alamein area. Windblown sand surrounds small bushes in shallow soil over limestone bedrock. This shows typical demining problems in the Western Desert: mines lie close to bedrock, and UXO's lie in minefield area. Extensive frag from fighting, lying on what was the surface in 1941-1943, generates many false alarms. In places, the sand has drifted to depths of up to 2 metres.

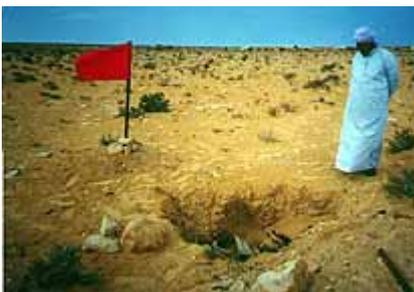
Photo: eg24-19a: The back end of a large British bomb can be seen inside the hole. The bomb was dropped on a British position heading south. The bomb was discovered during routine mine clearance in the area. It is awaiting an EOD team to destroy it in place, and the evacuation of the adjacent bedouin camp.

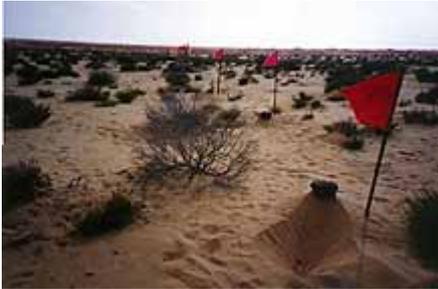
Photo: eg24-27a: Minefield being cleared. Each red flag denotes the position of a mine, all AT mines in this instance. Each mine has been located and removed from its position and placed alongside each hole. This can be a dangerous procedure as some mines have mechanisms which, if badly corroded, can activate the mine with the slightest movement.

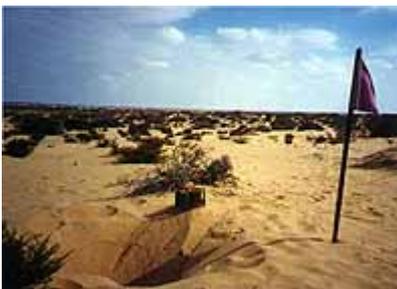
Photo: eg24-24a: British Mk 5 AT mine removed from its hole.

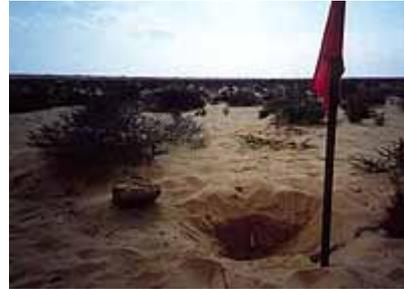
Photo: eg24-22a: Mk 4 AT mine removed from hole. The depth of sand above the mine was approximately 320mm here. Normal metal detectors should have no difficulty locating this kind of target.

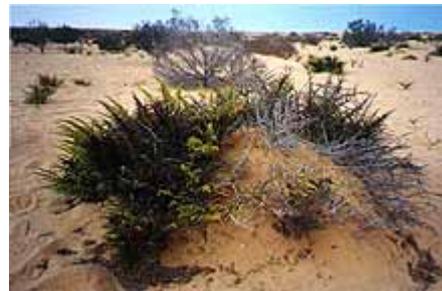
Photo: eg24-23a: Typical small bush. On the downwind side sand has built up in the bush. The prevailing winds are from the north west.

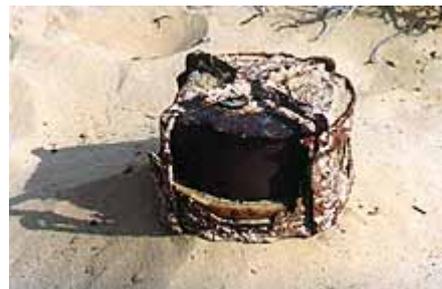
Photo: eg24-25a: Close up of Mk 5 AT mine showing advanced corrosion.

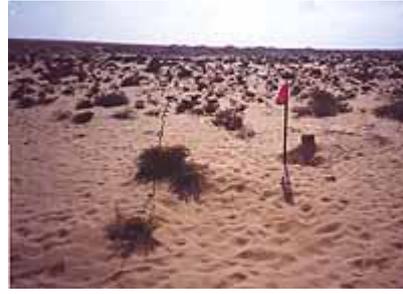
Photo: eg24-29a: Metal spring (found by deminers). The white flag behind the red flag indicates the edge of the minefield boundary.

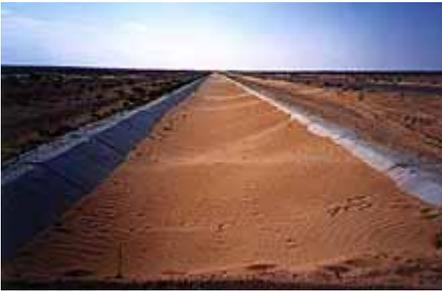
Photo: eg24-30a: New irrigation canal under construction through mined areas. The government wants to release land here for irrigated crops, using underground water. Note the blown sand indicating that sand is very mobile here under the right conditions.

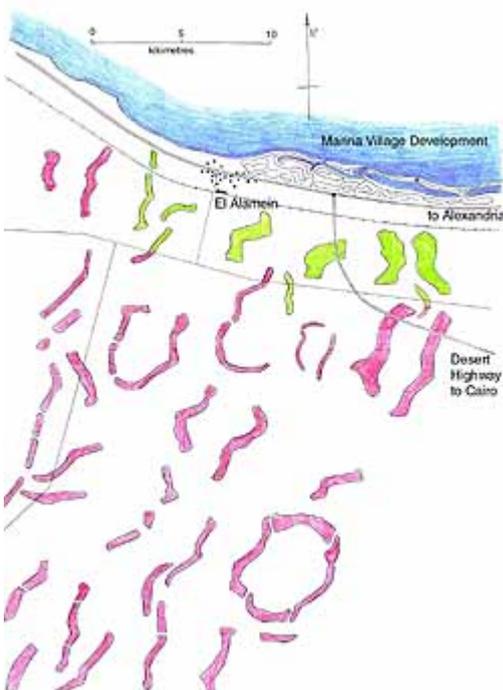
Drawing: Map of area drawn from memory. Shapes are indicative only of minefield records which are partly misleading because of the limited accuracy of those records. UXO (and some mines) lie scattered across entire area so the entire area has to be cleared.
